A Visitors Guide to St. Nicholas' Church, Boarhunt

St. Nicholas' Church, Boarhunt

The purpose of this short guide is to tell you what we know about the history of the church and its surroundings and point out items of interest you will see as you walk round. The guide incorporates descriptions and a plan that were originally published by J.T. Irvine in 1877.

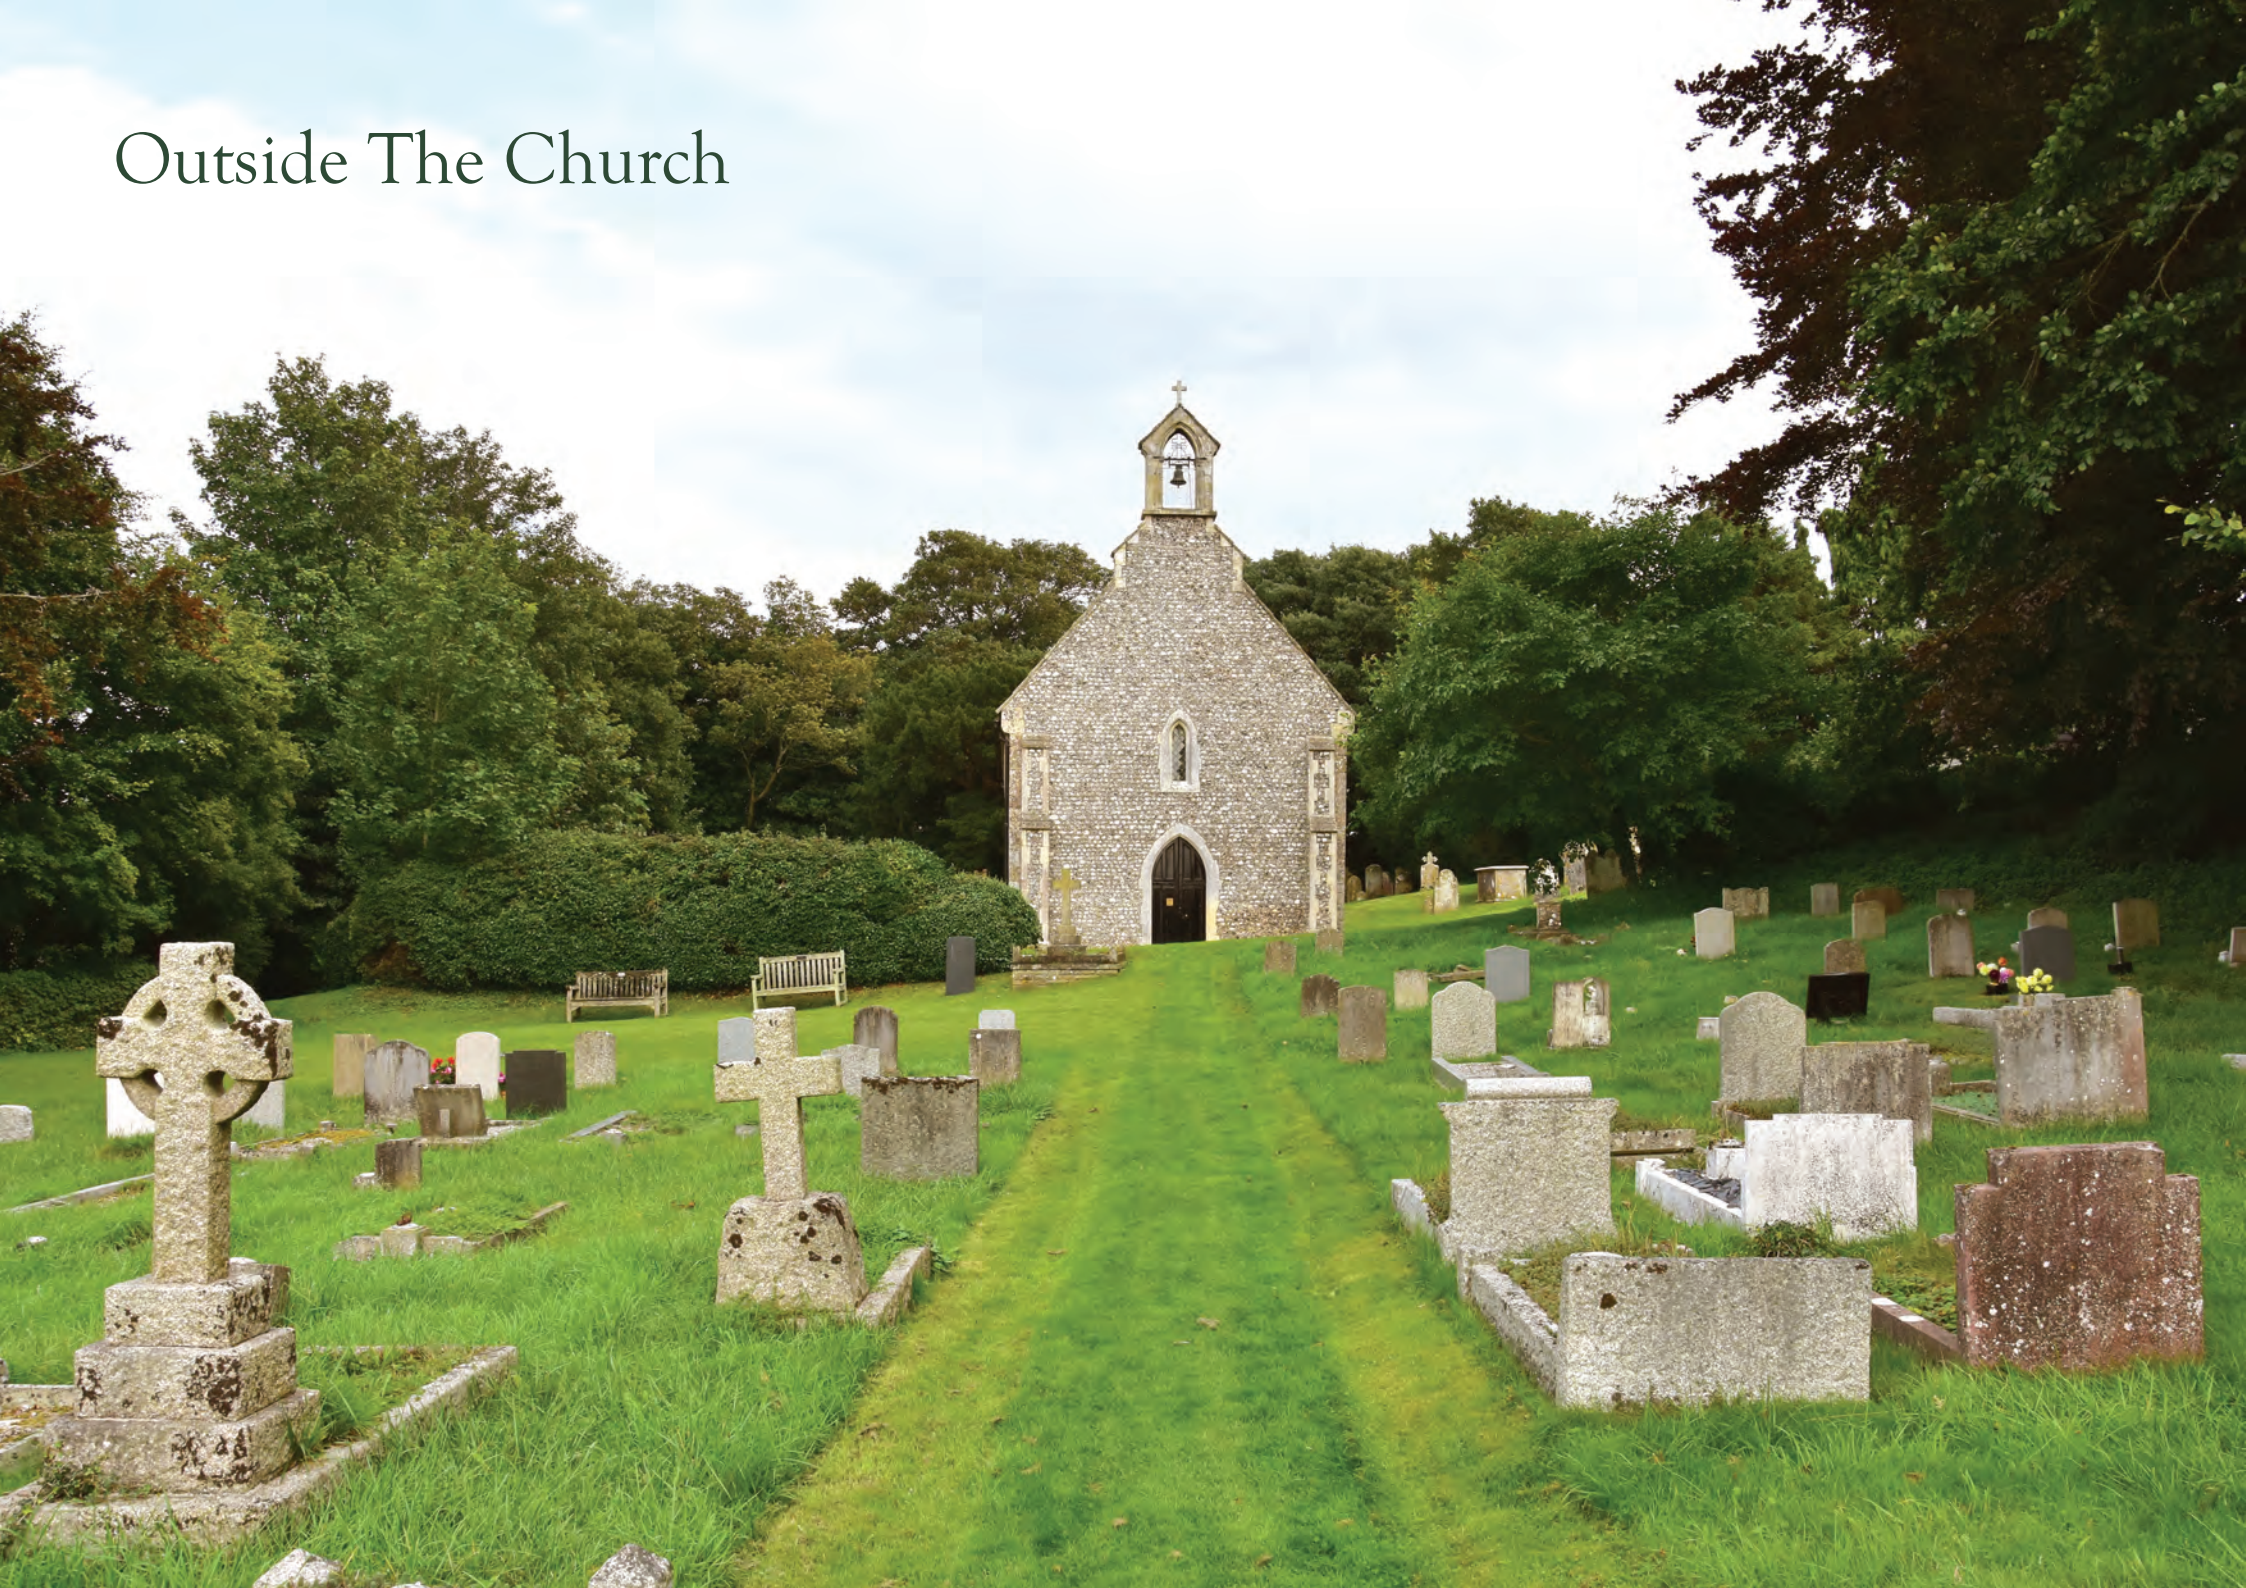
The walls of the church are rubble and flint and the west wall has been refaced with knapped flint and flint gallets. The two external buttresses (B) supporting the west wall were built using Bath stone probably at the time of the 1853 restoration.

The open bell turret, again dating from the 1853 restoration, has been formed as an archway, with delicately moulded pillars and is roofed with stone tiles.

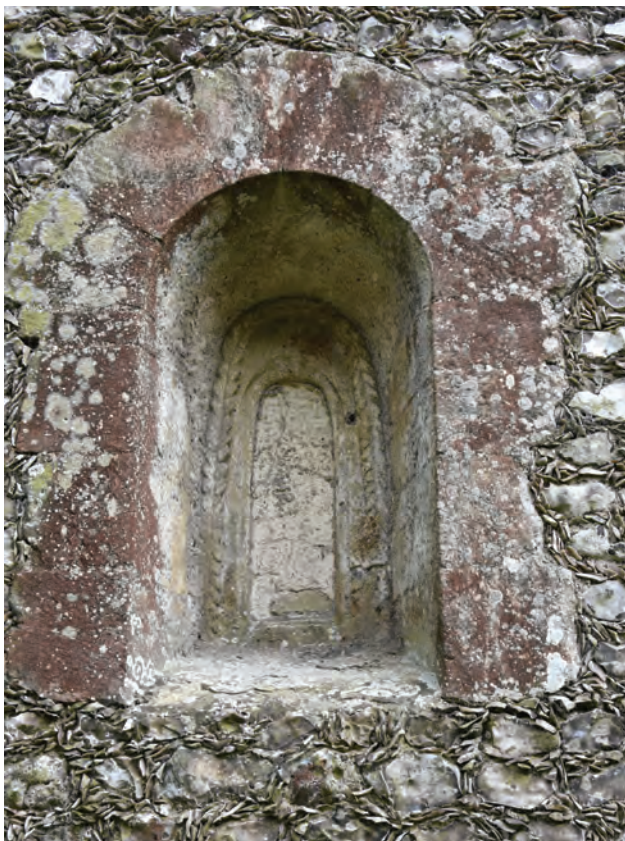
The window in the north wall of the chancel (R) is the one almost completely blocked inside the church by the Henslow monument. From outside, it can be seen to be an excellent example of a double-splayed Saxon window opening, decorated with a double line of cable-moulding. No trace of an early light opening, except this one, can be seen anywhere throughout the church. It therefore could have been the only window in Saxon times. There is some evidence that a wooden shutter was fitted at a later date.
